NASA Technical Paper 3468  
ARL Technical Report 480

# Ten-Year Ground Exposure of Composite Materials Used on the Bell Model 206L Helicopter Flight Service Program

*Donald J. Baker*  
*Vehicle Structures Directorate*  
*U.S. Army Research Laboratory*  
*Langley Research Center • Hampton, Virginia*

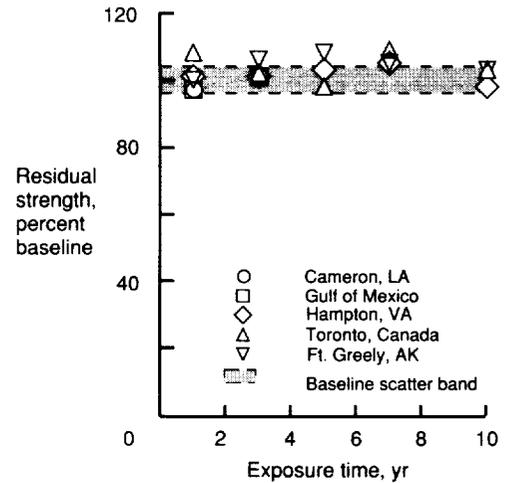
Figure 15. Effect of exposure time and location on residual tension strength of T-300/E-788.
